Manhole Inspection Summary

Manhole # S21II_017MH

Insp Date: **6/25/07 9:59 AM**

Location Address: **1734 FULTON-BRUCE**

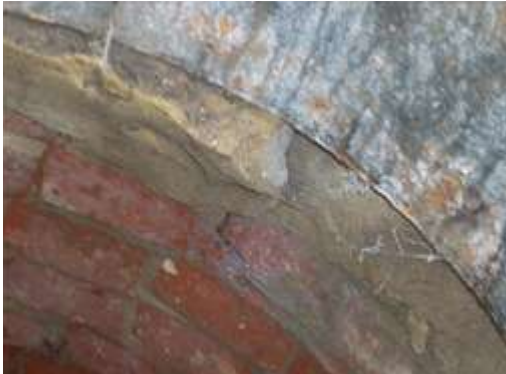
Defect 2

Condition: ☐ Sound ☒ **Cracked** ☐ Root Intrusion ☐ Loose Brick ☒ **Deteriorated**

DETERIORATION AND CRACKED
CHIMNEY

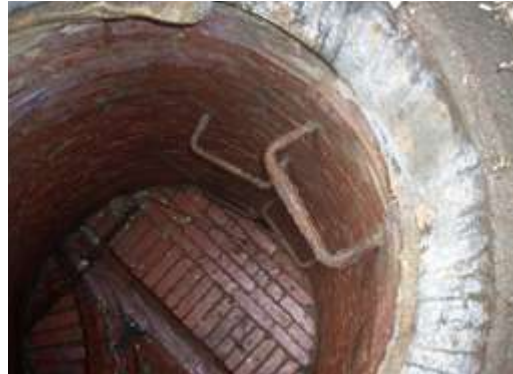
Defect 1

Count: **4** Missing: **0** ☒ **Corroded**

CORRODED STEPS

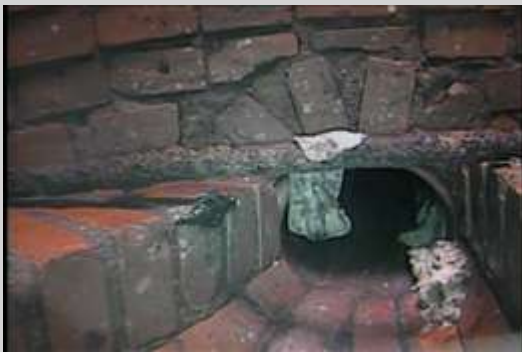
12 O'Clock Outflow

Pipe Height: **8.4** (in.) Rod and Bar (Angled)
Pipe Material: **Clay** ☐ Pipe Lined
Invert Depth: **8.46** (ft.) Flow Characteristics: **Slow**
Deposits: ☐ None ☐ Mud ☐ Sludge ☐ Debris ☒ Grease
Silt Depth: **1** (in.) Deposits Extent: **Light**
Infiltration: **None** Pipe Seal Cond: **Sound**
